REPORT NOS. 208-TRC-91-003
212-TRC-91-003
301-TRC-91-003

VEHICLE SAFETY COMPLIANCE TESTING
FOR OCCUPANT CRASH PROTECTION,
WINDSHIELD MOUNTING, WINDSHIELD ZONE
INTRUSION, AND FUEL SYSTEM INTEGRITY

1991 BMW 318is

NHTSA NO. CM0503

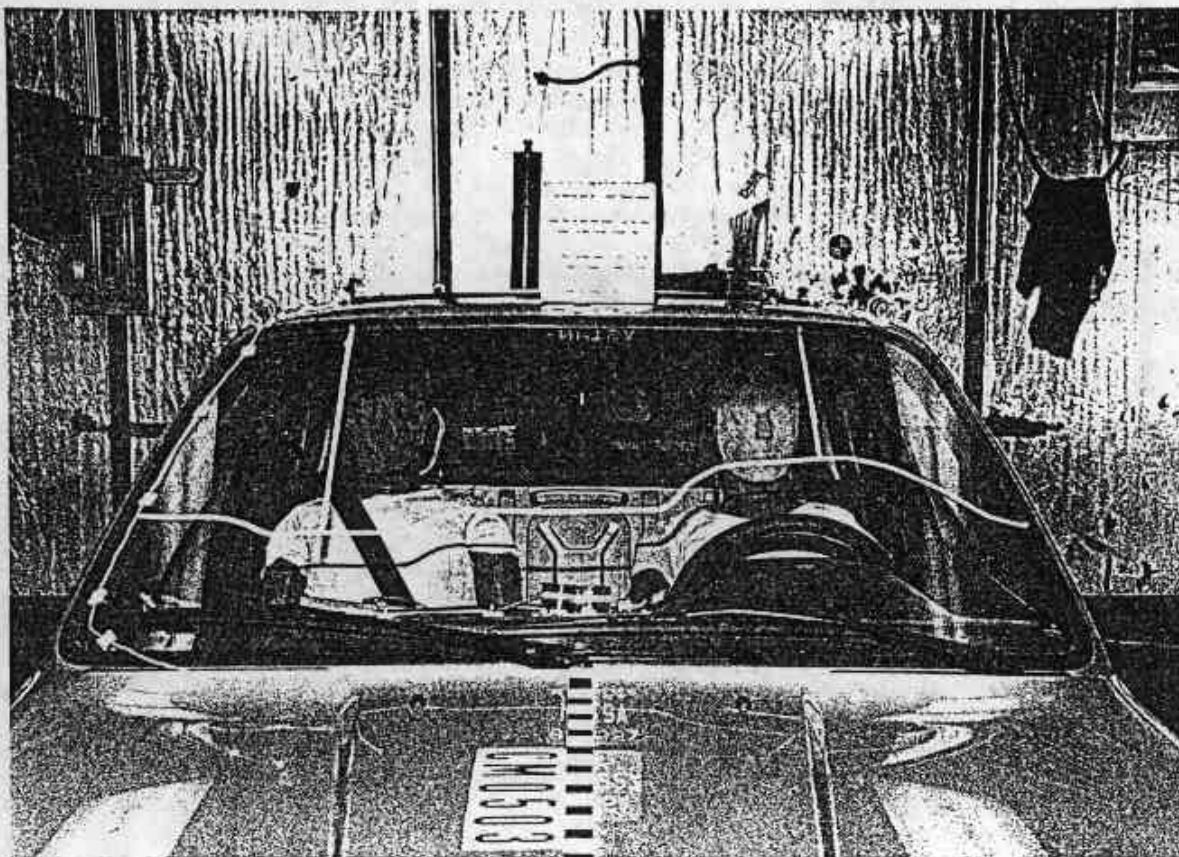
Figure A-13. PRE-TEST WINDSHIELD VIEW

There was no loss of windshield periphery retention.

There was no intrusion through the windshield.

The right portion of the windshield was cracked upon impact.
